# Manhole Inspection Summary

Manhole # S19Y\_\_010MH

Insp Date: **6/19/08 9:59 AM**

**Location** Address: **2367 breitwert av**

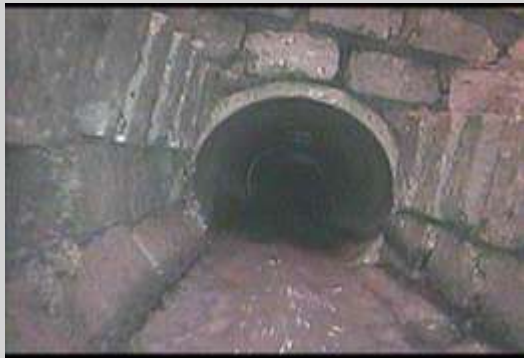
12 O'Clock Outflow

8 in. Circular Gravity Sewer  
Pipe Out @ 12 O'Clock

Pipe Height: **8.4** (in.) Rod and Bar (Angled)  
Pipe Material: **Clay** ☐ Pipe Lined  
Invert Depth: **6.30** (ft.) Flow Characteristics: **Slow**  
Deposits: ☒ None ☐ Mud ☐ Sludge ☐ Debris ☐ Grease  
Silt Depth: **0** (in.) Deposits Extent:  
Infiltration: **None** Pipe Seal Cond: **Sound**

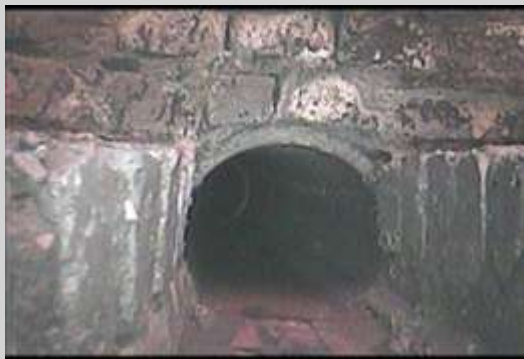
3 O'Clock Inflow

8 in. Circular Gravity Sewer  
Pipe In @ 3 O'Clock

Pipe Height: **8.4** (in.) Rod and Bar (Angled)  
Pipe Material: **Clay** ☐ Pipe Lined  
Invert Depth: **6.21** (ft.) Flow Characteristics: **Slow**  
Deposits: ☒ None ☐ Mud ☐ Sludge ☐ Debris ☐ Grease  
Silt Depth: **0** (in.) Deposits Extent:  
Infiltration: **None** Pipe Seal Cond: **Sound**
